(11)【東五反田川隣】 状況写真

その他水系 東五反田川隣 災害関連緊急砂防工事 (尾道市吉和町)

施工:株式会社タカマツ建設, 株式会社堀田組

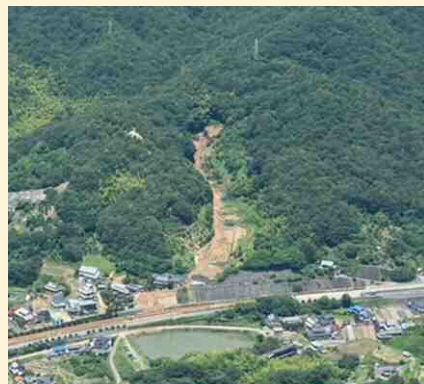
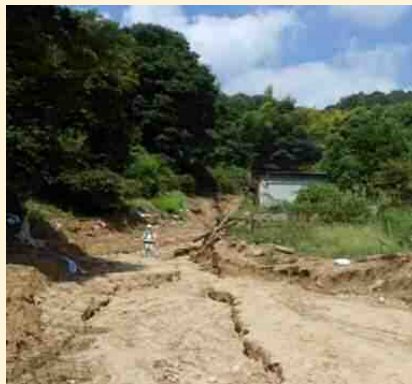
被災状況

- ・住家等被害：半壊 3戸
- ・人的被害：死亡者数 0人
- ・公共施設被害：市道 L=約900m
国道 L=約250m

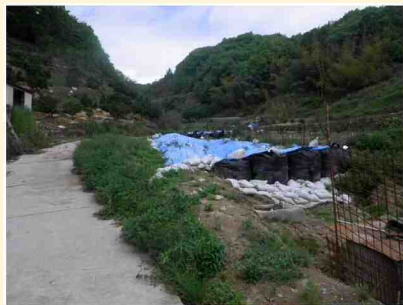
(1)2019.6 着工前

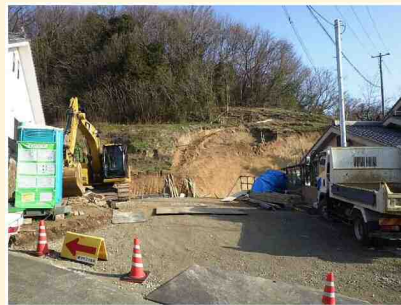
(2)2020.2 工事用道路施工①

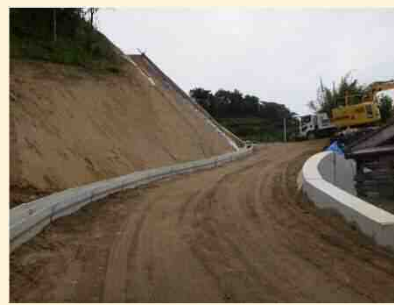
(3)2020.5 工事用道路施工②

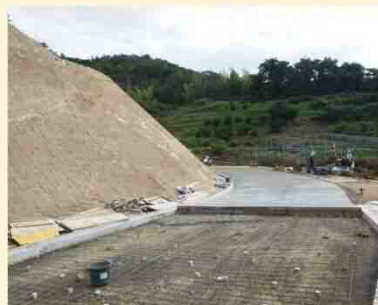
(4)2020.6 工事用道路施工③

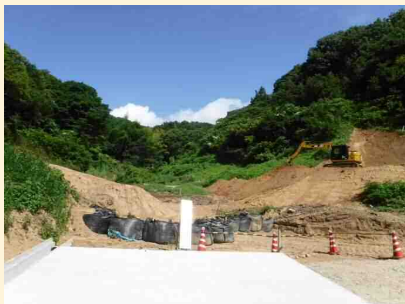
(5)2020.7 本堰堤掘削工

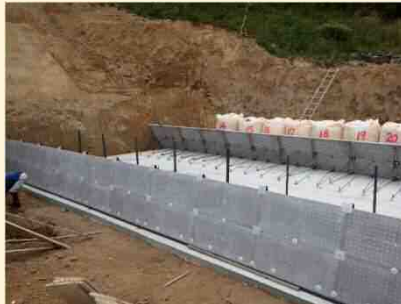
(6)2020.8 本堰堤打設状況①

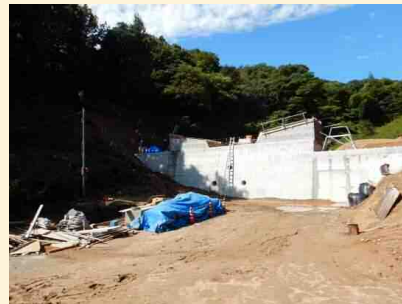
(7)2020.10 本堰堤打設状況②

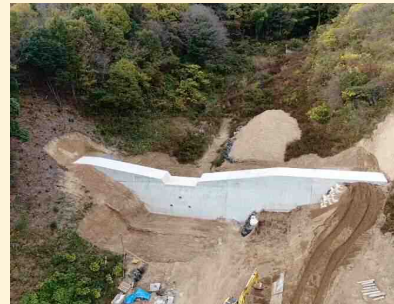
(8)2020.12 本堤工打設完了

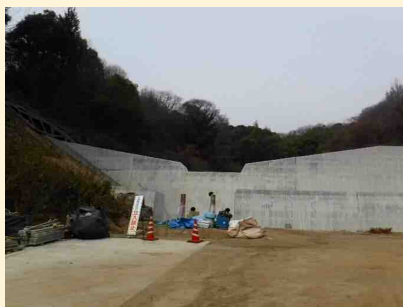
(9)2021.2 副堰堤打設状況

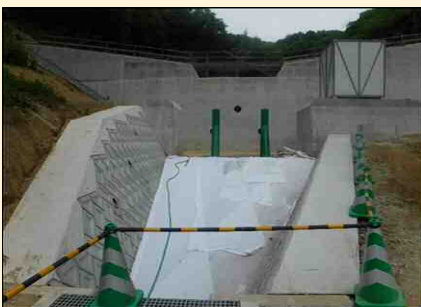
(10)2021.6 取付護岸工

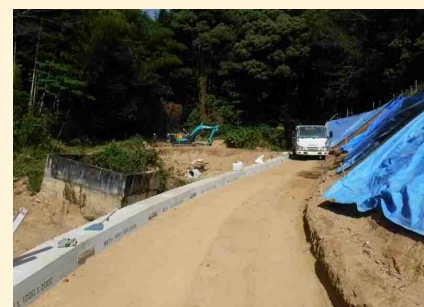
(11)2021.10 付替農道工①

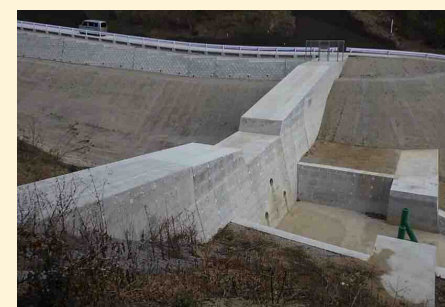
(12)2022.3 完成
